1. Introduction

[REDACTED] Christchurch [REDACTED]

2. Brief

Building assessment of [REDACTED] based on a building report that identified earthquake damage to the subfloor. This damage is believed to be either 'missed damage', 'mis-scoped damage' or 'failed repairs' of which EQC are said to be responsible for.

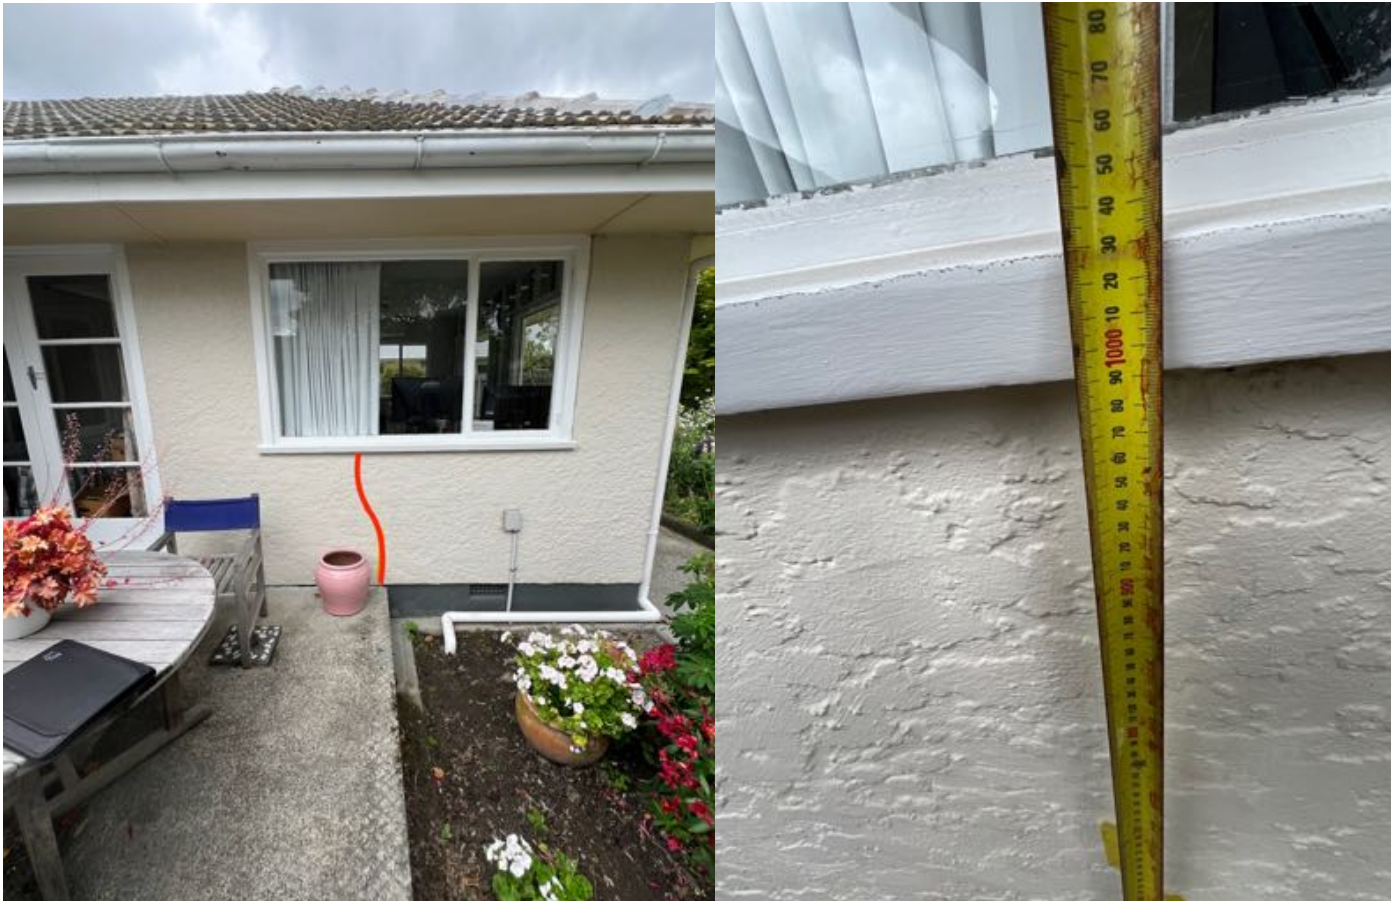
Figure 1 & 2: East elevation (entrance). Signs of cracking in Stucco.

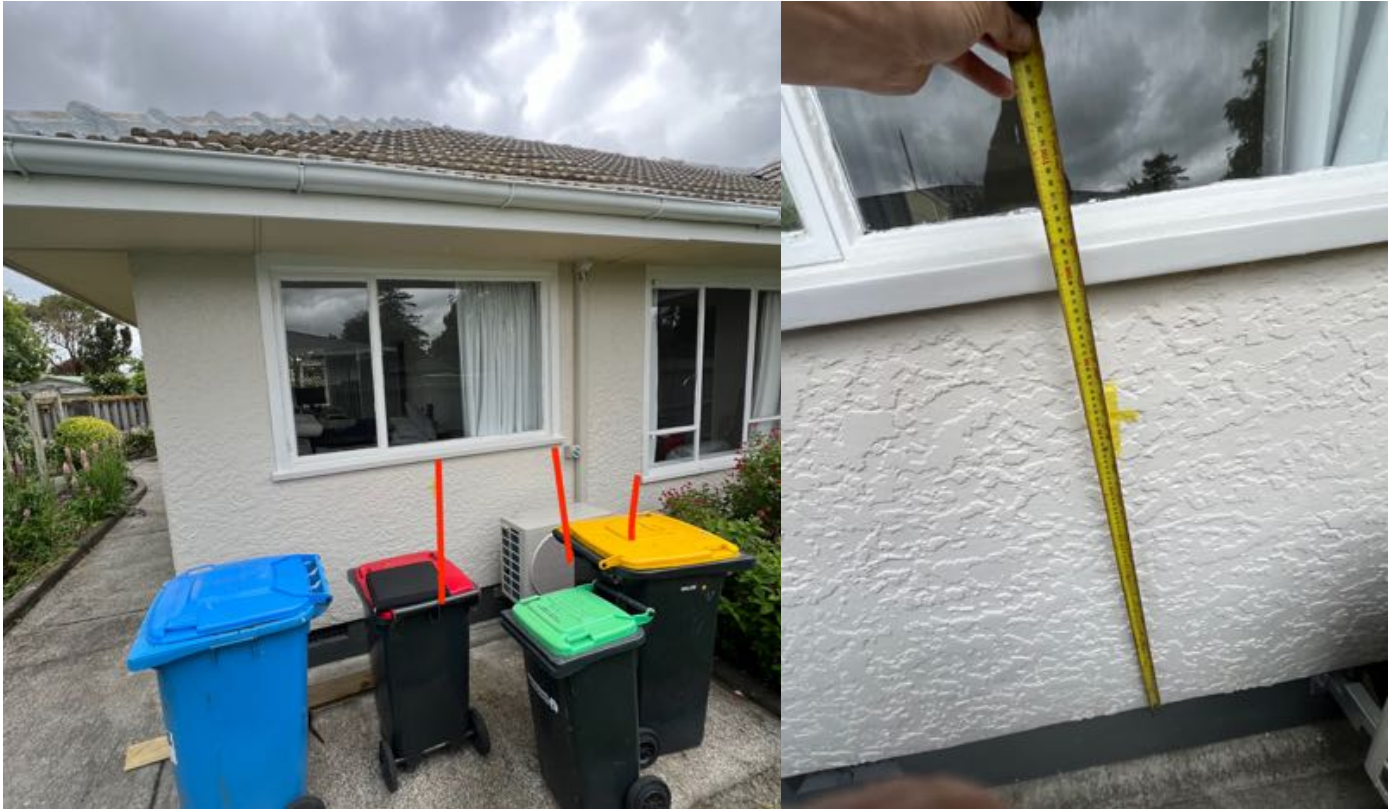
Figure 3 & 4: West elevation. Signs of cracking in Stucco.

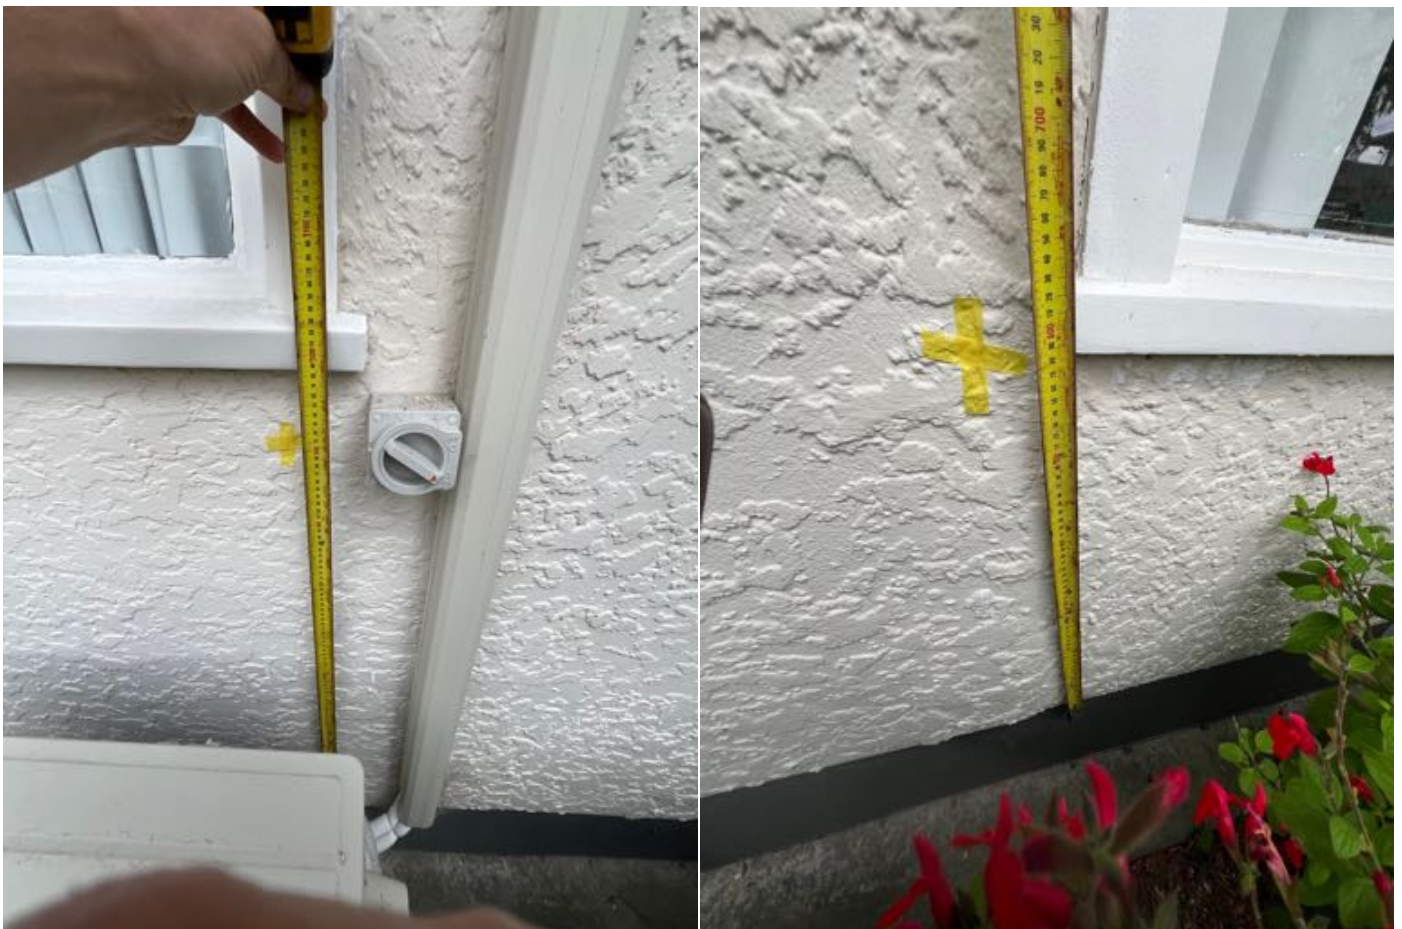
Figure 5 & 6: West elevation continued. Signs of cracking in Stucco.

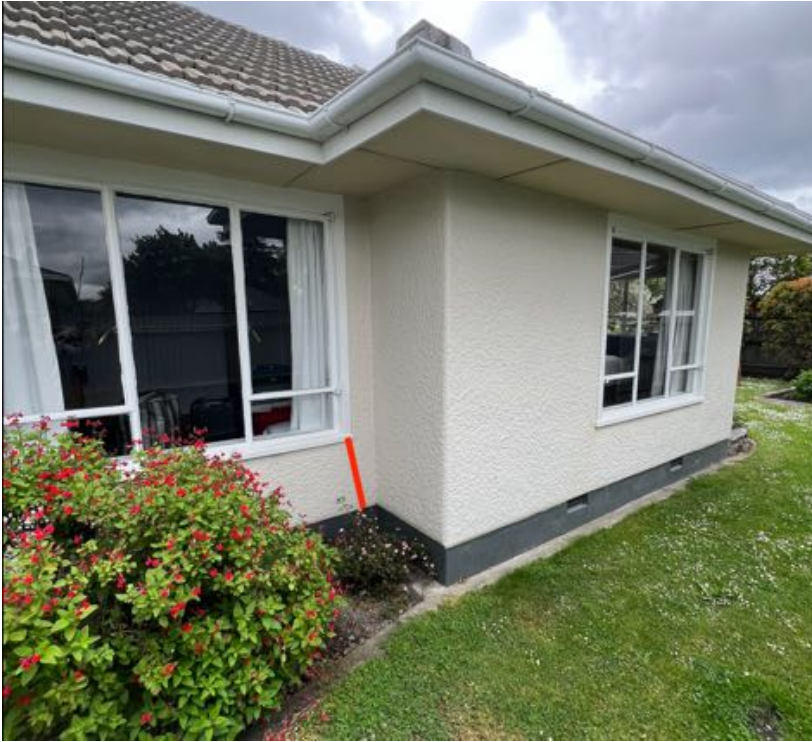
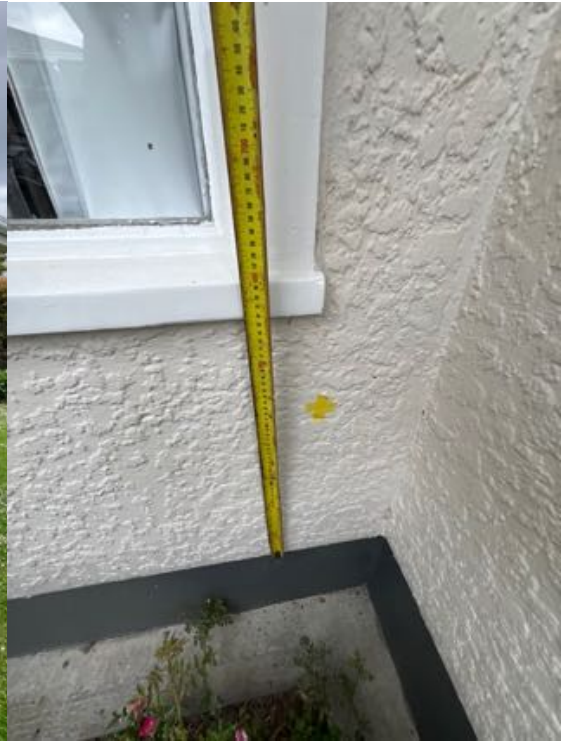
Figure 7 & 8: West elevation continued. Signs of cracking in Stucco.

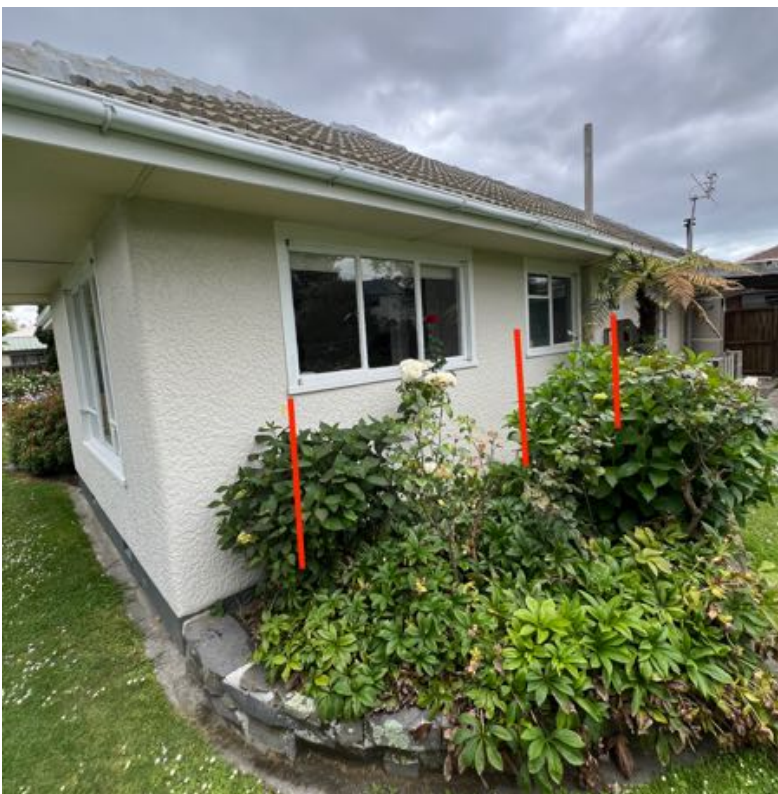
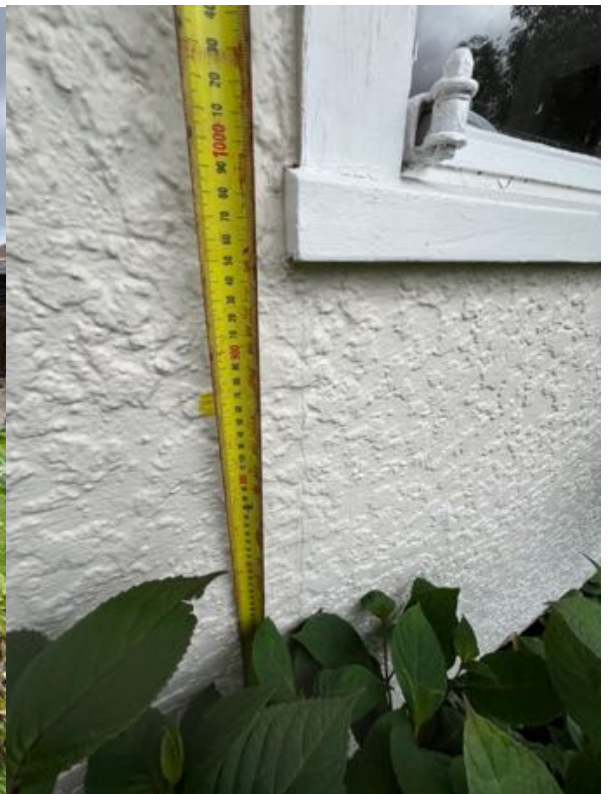
Figure 9 & 10: South elevation. Signs of cracking in Stucco.

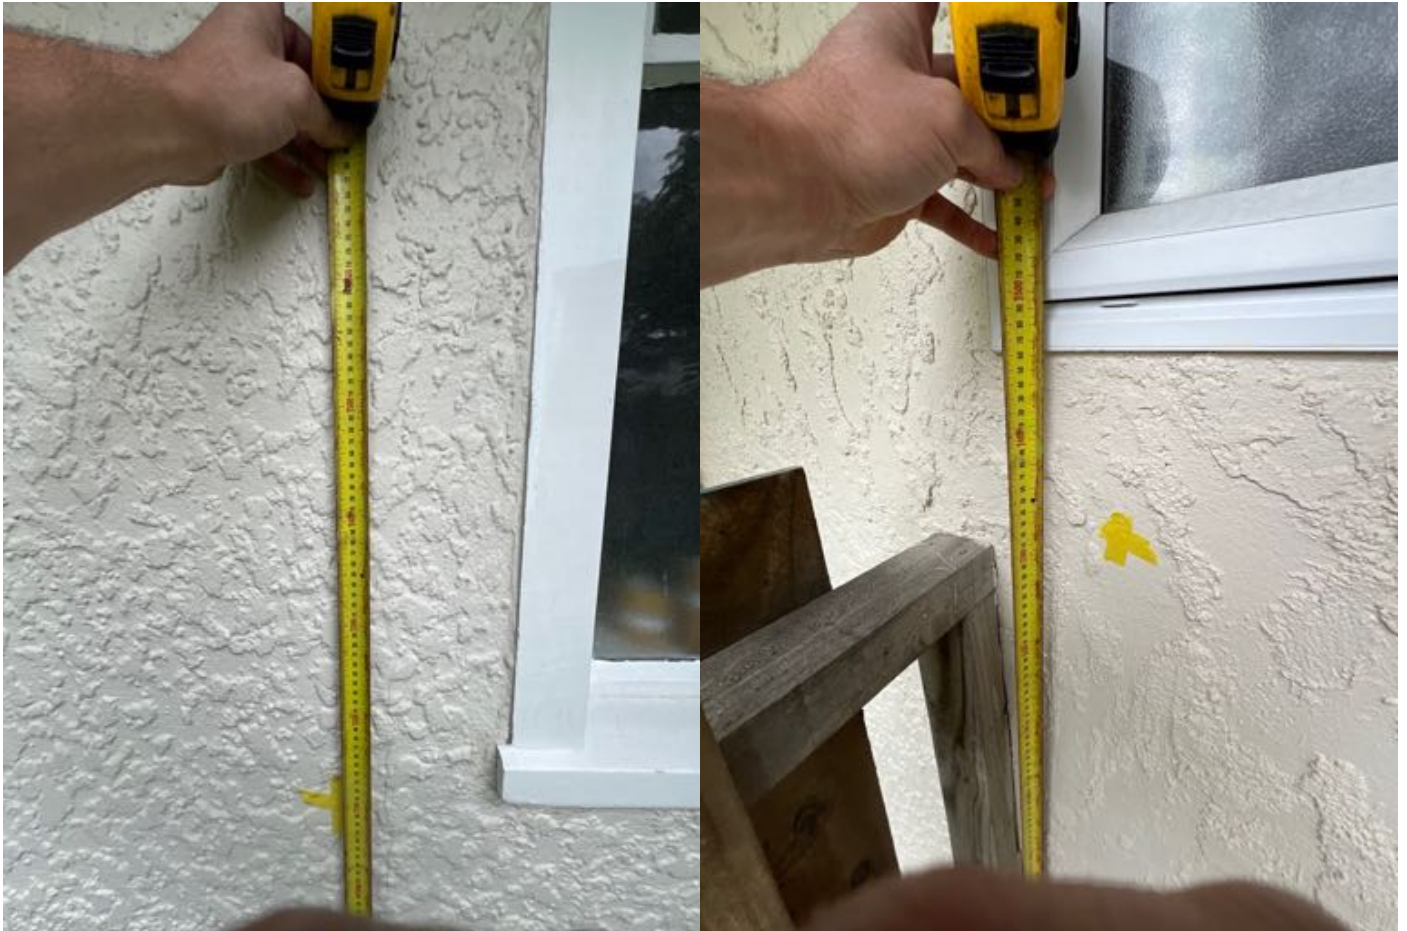
Figure 11 & 12: South elevation continued. Signs of cracking in Stucco.

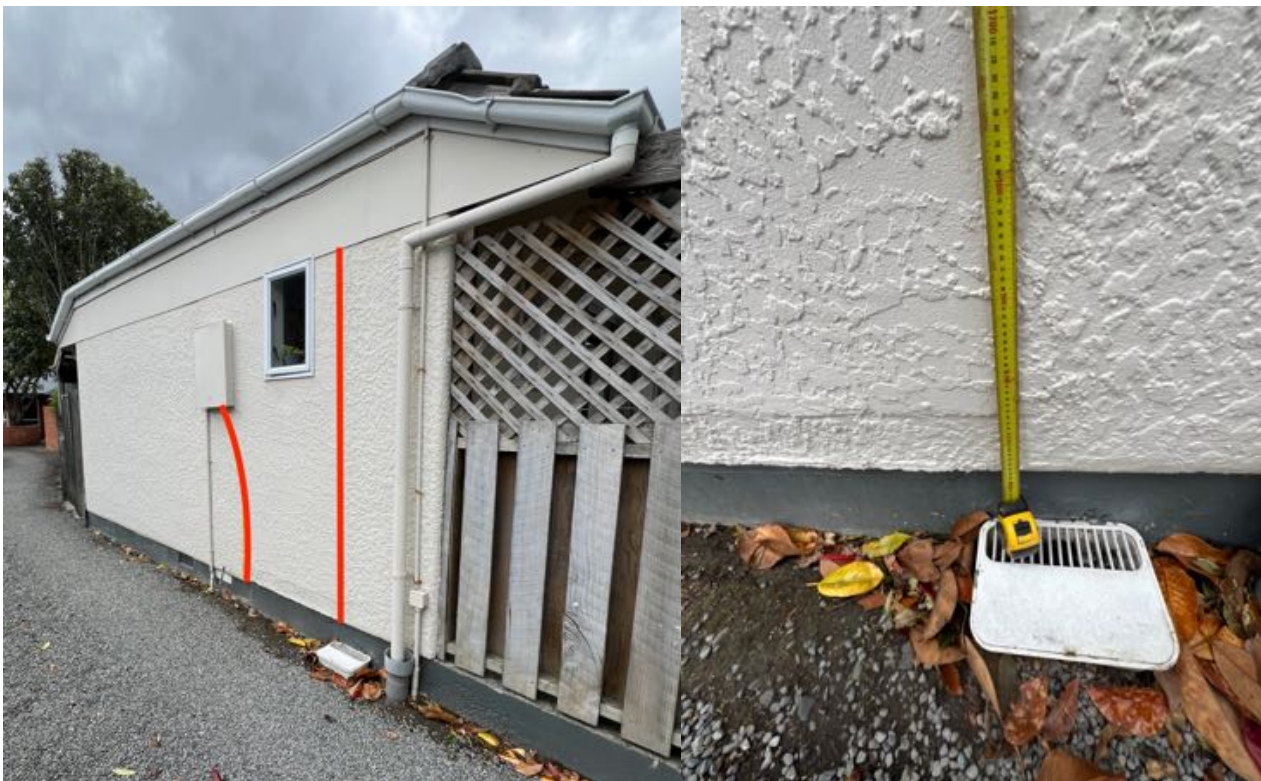
Figure 13 & 14: East elevation (driveway). Signs of cracking in Stucco.

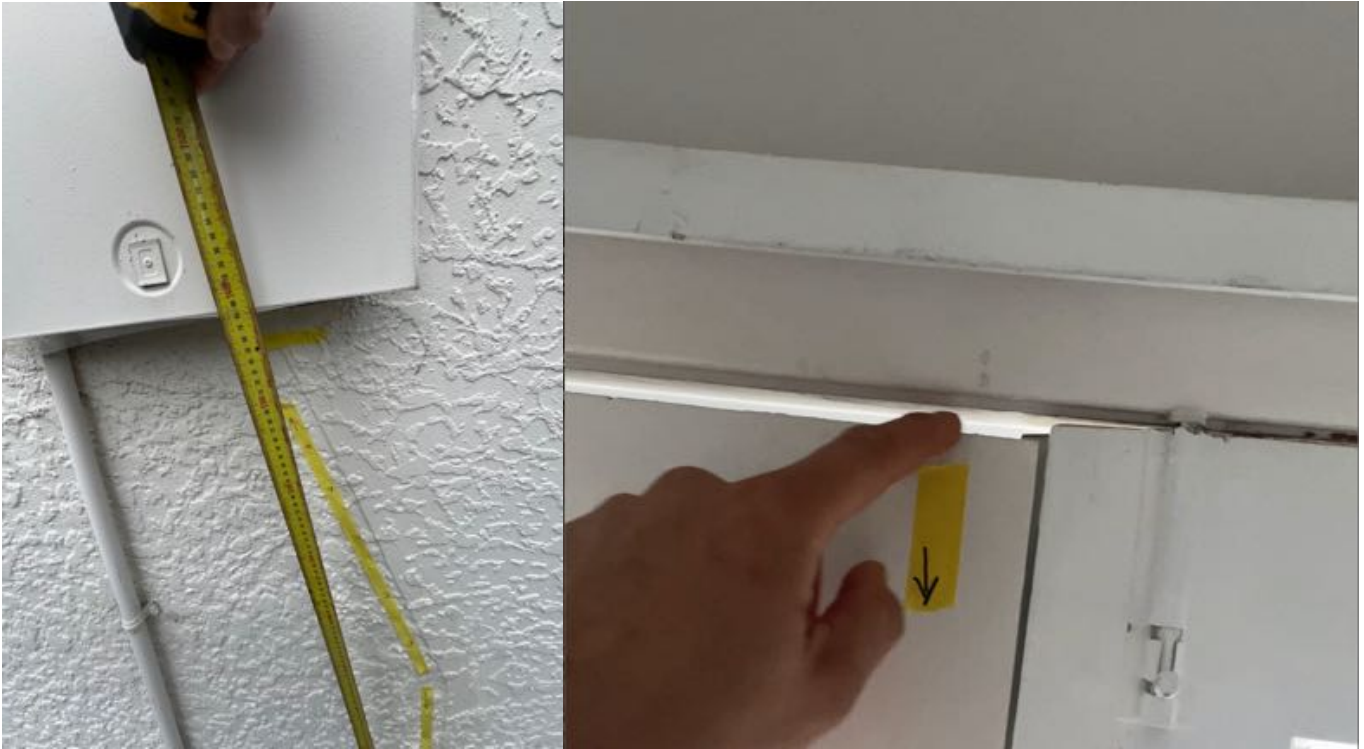
Figure 15 & 16: East elevation continued (driveway). Signs of cracking in Stucco. Photo on right showing double door on East elevation (entrance). Signs of door frame dropping due to floor level

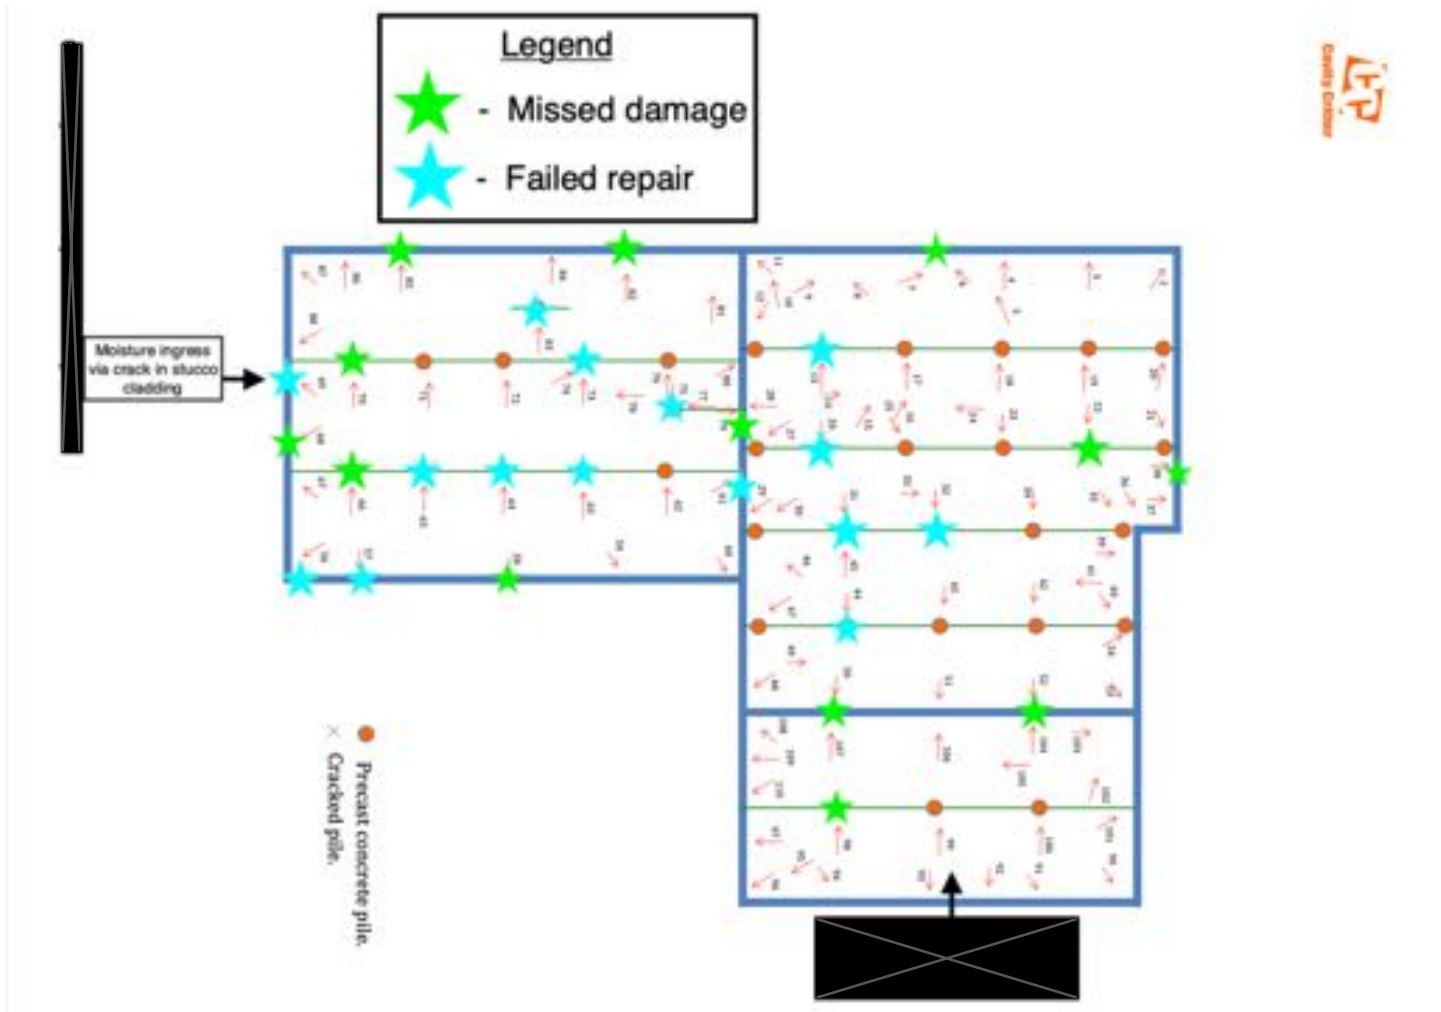
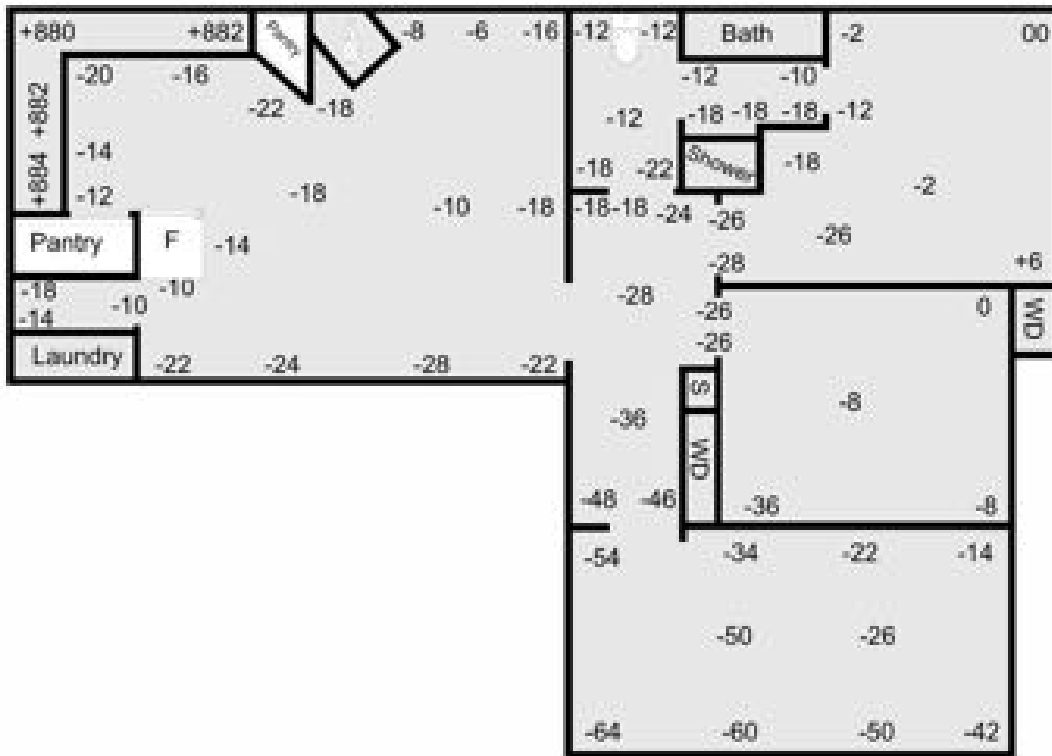
- 11 x failed repairs to piles
- 4 x failed repairs to subfloor framing
- 4 x missed damage to piles
- 9 x missed damage to concrete perimeter foundation
- 60mm max floor level deviation

Our recommendation is for EQC to engage a structural Engineer to conduct a Preliminary Structural Assessment to report on the Cavity Critter report. They should also conduct their site survey which will include a floor level survey and assessment of door & window sills, wall tilt etc.
